Name of Dam: South River No. 23

Inventory Number: VA 01508

PHASE I INSPECTION REPORT NATIONAL DAM SAFETY PROGRAM

SEPTEMBER 1979

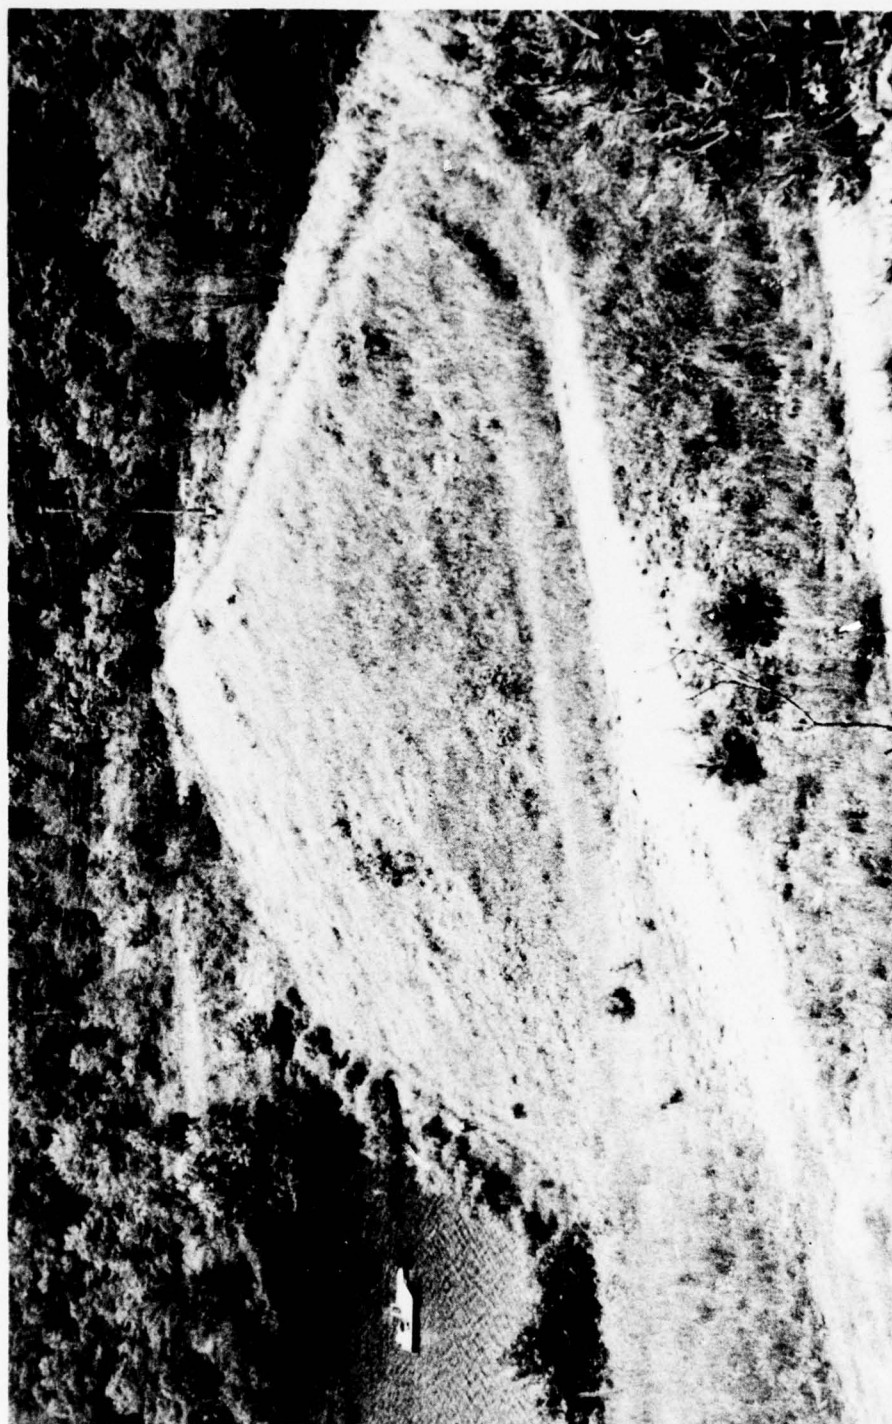
OVERALL VIEW OF DAM

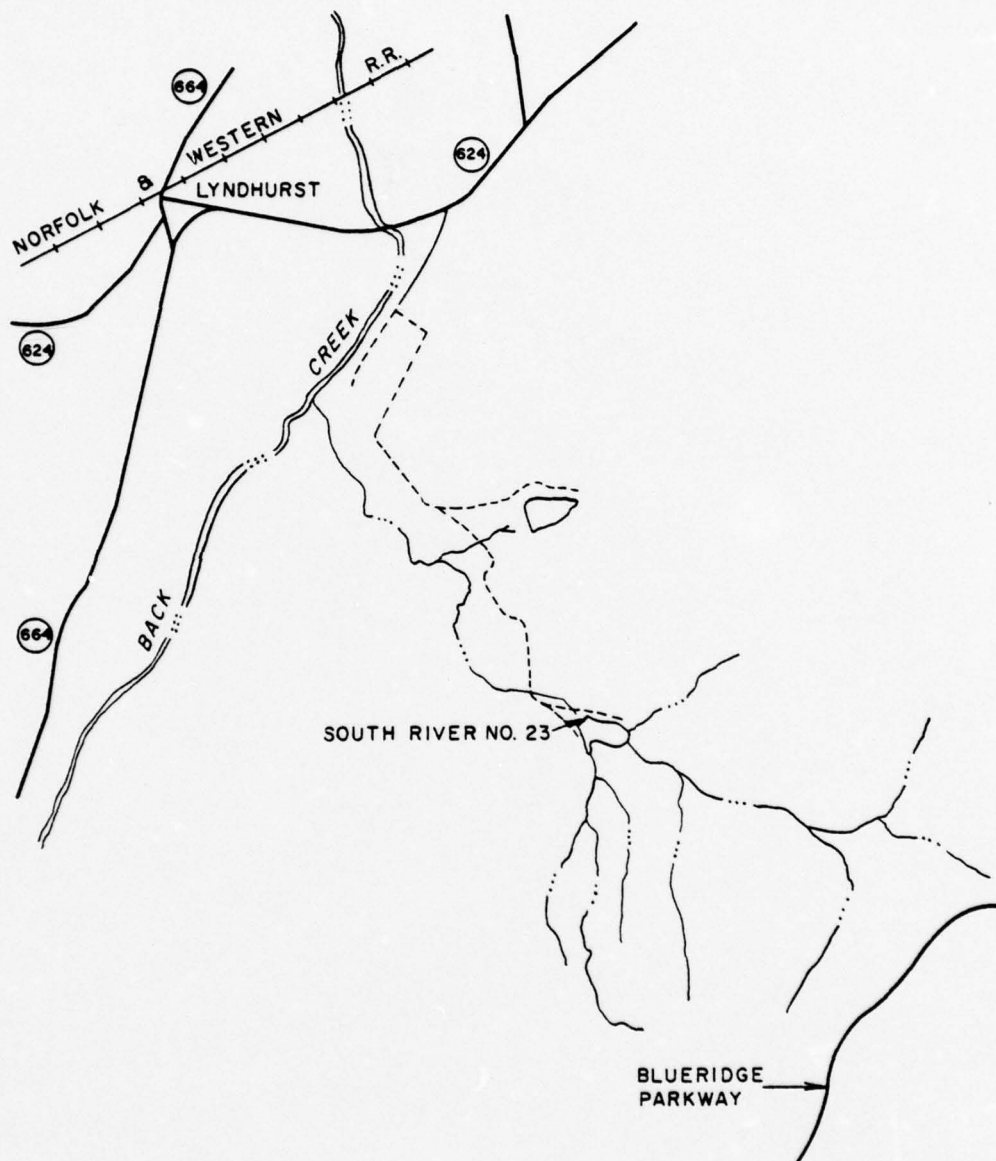
Plate 1: Field Sketch

Plate 1 is a Field Sketch of the facility which depicts the conditions observed during the visual inspection. The complete visual inspection check list is included in Appendix III. Following are summaries of the deficiencies noted during the inspection.

3.1.2 Dam: The upstream and downstream embankment slopes are 2.5:1. A few sparsely vegetated areas are located on the upstream embankment slope which are prone to erosion. Small trees have also been allowed to root on the upstream slope at the waterline. Jeeps have traversed numerous parts of the dam as shown on Plate 1. This jeep traffic has caused minor erosion of the ends of the dam bordering the emergency spillways (see Overall View of Dam and Photo 5). Other potential problems are indicated by jeep tracks which cross the upstream slope just above the waterline, the bench on the downstream slope, and all of the abutment slopes. A jeep track is also located on the right side of the downstream embankment slope. Animal burrows were observed in the junction of the upstream embankment slope with the right abutment and the left downstream junction.
